Manhole Inspection Summary

Manhole # S29Q__004MH

Inspection ☐ Is Incomplete Rating: **3) Fair**

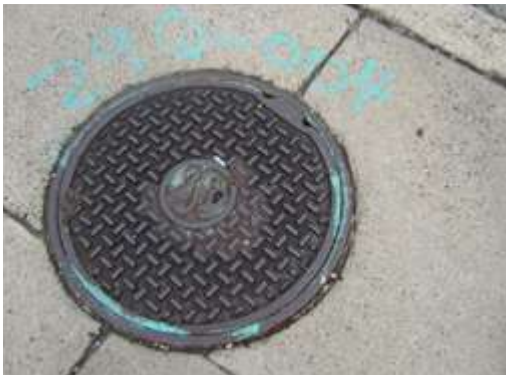
mh cover

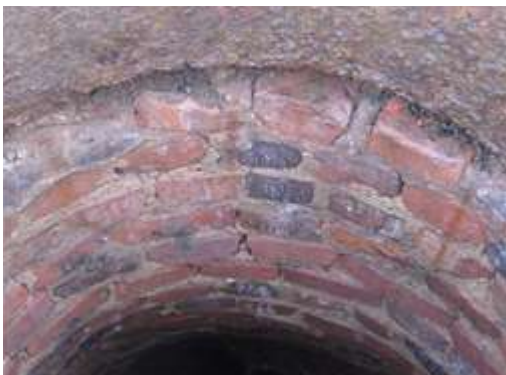
Defect 3

Chimney / Frame Adjustment ☒ Exists Material: **Brick** ☐ Parged Height: **4** (in.)
Condition: ☐ Sound ☒ **Cracked** ☐ Root Intrusion ☒ **Loose Brick** ☒ **Deteriorated**
Infiltration: ☐ None ☒ **Joint** ☐ Cracks ☐ Mortar ☐ Roots ☒ **Wall**

cracked chimney Loose brick,
deteriorated

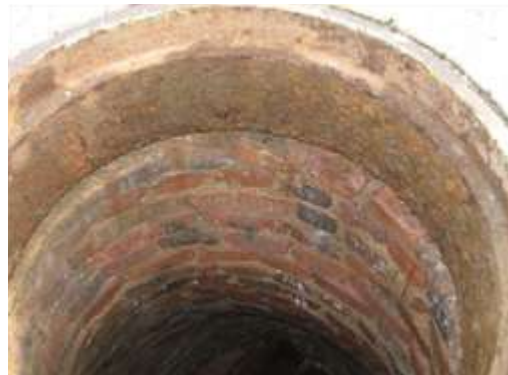
Defect 4

Frame Offset: **0** (in.) Condition: ☐ Sound ☐ Cracked ☒ **Leaks**

infiltration frame and chimney

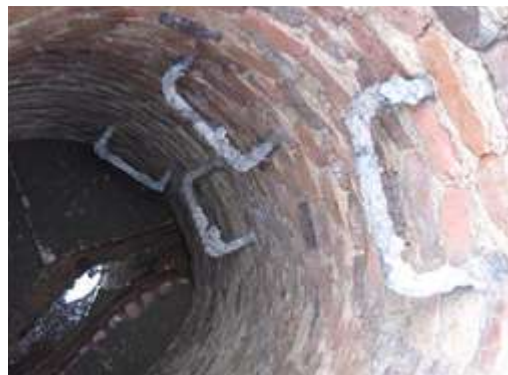
Defect 2

Steps Count: **4** Missing: **0** ☒ **Corroded**

corroded rungs

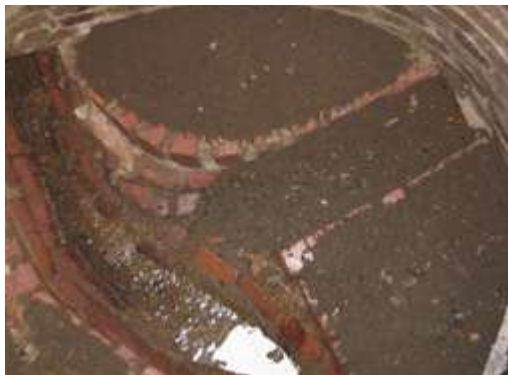
Defect 1

Bench ☒ Exists Material: **Brick** ☐ Parged
Condition: ☐ Sound ☐ Cracked ☐ Root Intrusion ☐ Deteriorated ☐ Leaks ☒ **Debris**

Channel Material: **Brick** ☐ Parged
Channel Exposure: **Fully Open** Junc Dist: **0** nearest .5 ft. Azimuth: **0**
Condition: ☐ Sound ☐ Cracked ☐ Root Intrusion ☐ Deteriorated ☐ Leaks ☒ **Debris**

sediment on bench and in channel
